Technical note

## ELECTRON BEAM DAMAGE DURING TESTING OF WOOD IN THE SEM

P.Hoffmeyer, Building Materials Laboratory,  
Technical University of Denmark

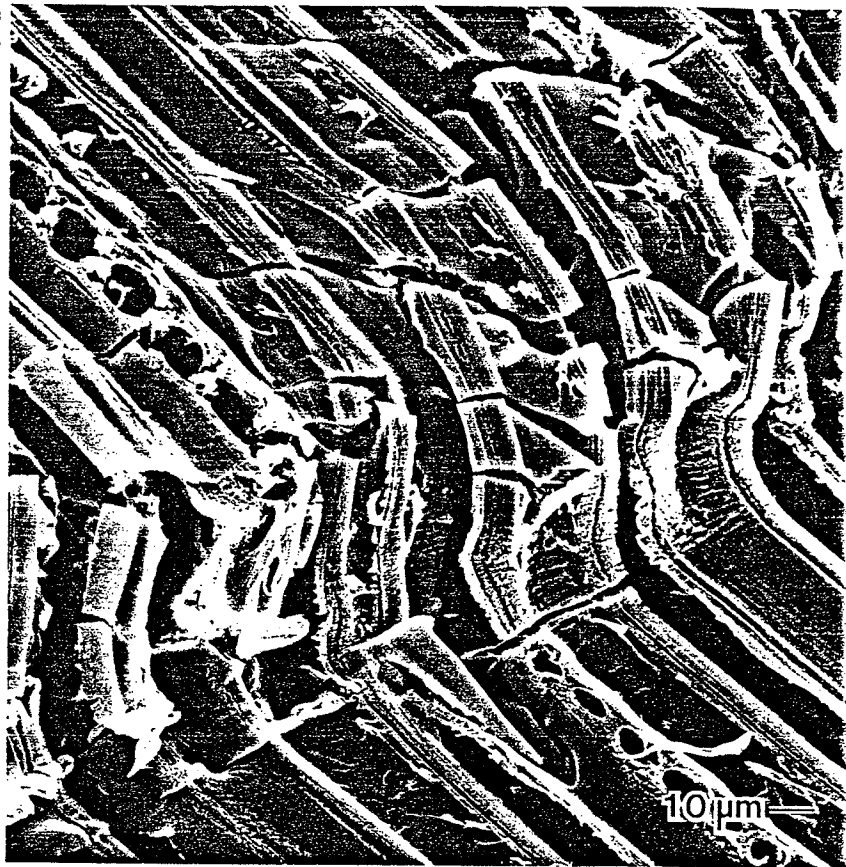
**RESULTS:** Micrographs of failures showed a distinct difference in morphology of the failure depending on whether or not specimens had been exposed to the electron beam during the compression testing. Figures 1 and 2 show the glassy fracture of wood exposed to the electron beam as opposed to the ductile folding of the cell walls exposed to vacuum but not to the electron beam (Figure 3). The ductility of the latter is clearly illustrated in Figure 4, which shows the result of a gradual separation of an S2-wall, whereby bundles of microfibrils are bent and subsequently stretched with no signs of brittleness. An equally significant difference in failure morphology for exposed- and unexposed wood was found for the two dry specimens of compression wood. There was found no evidence of any significant brittleness for unexposed wood of different moisture content levels.

Fig. 1 Compression failure of spruce exposed to electron beam during testing

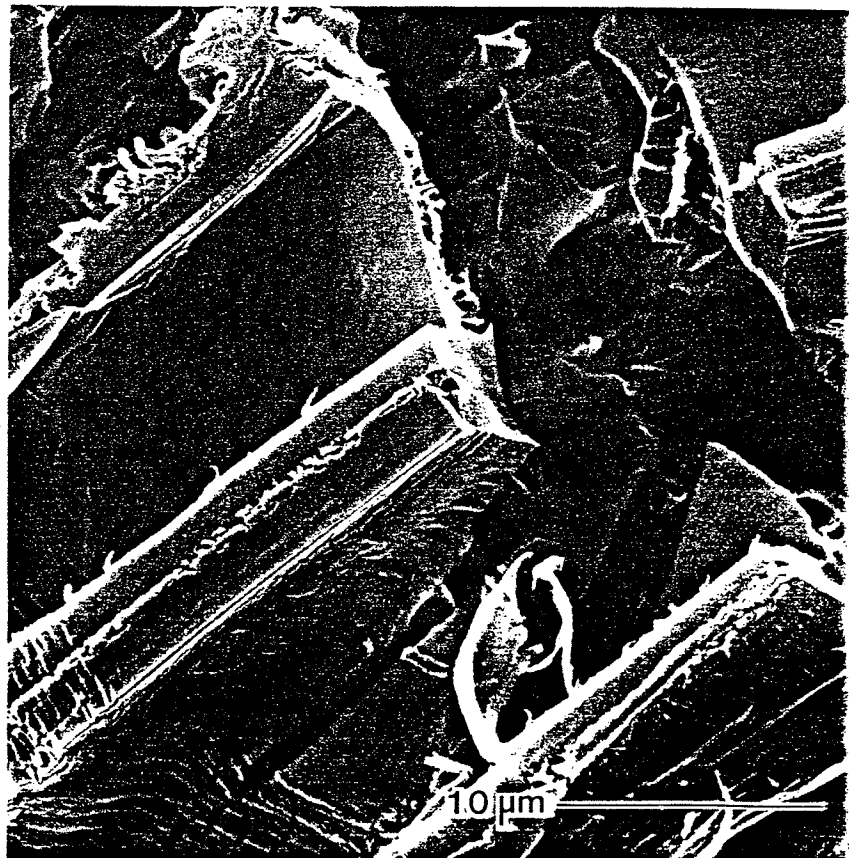
Fig. 2 Compression failure of spruce exposed to electron beam during testing.

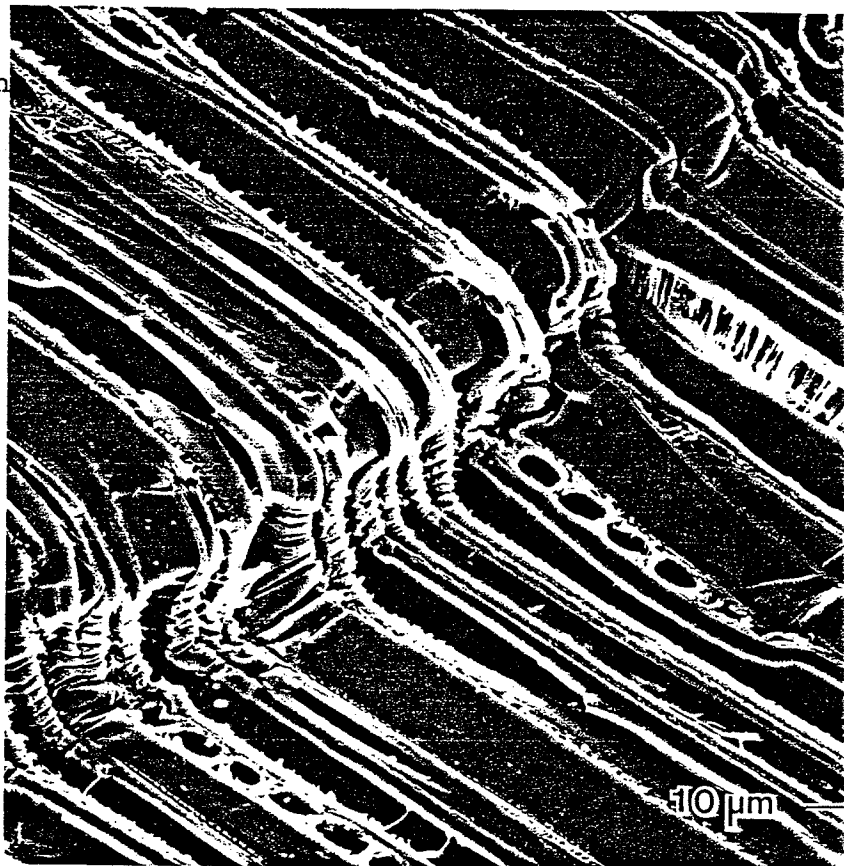
Fig.3 Compression failure of spruce tested in vacuum but not exposed to electron beam during testing.

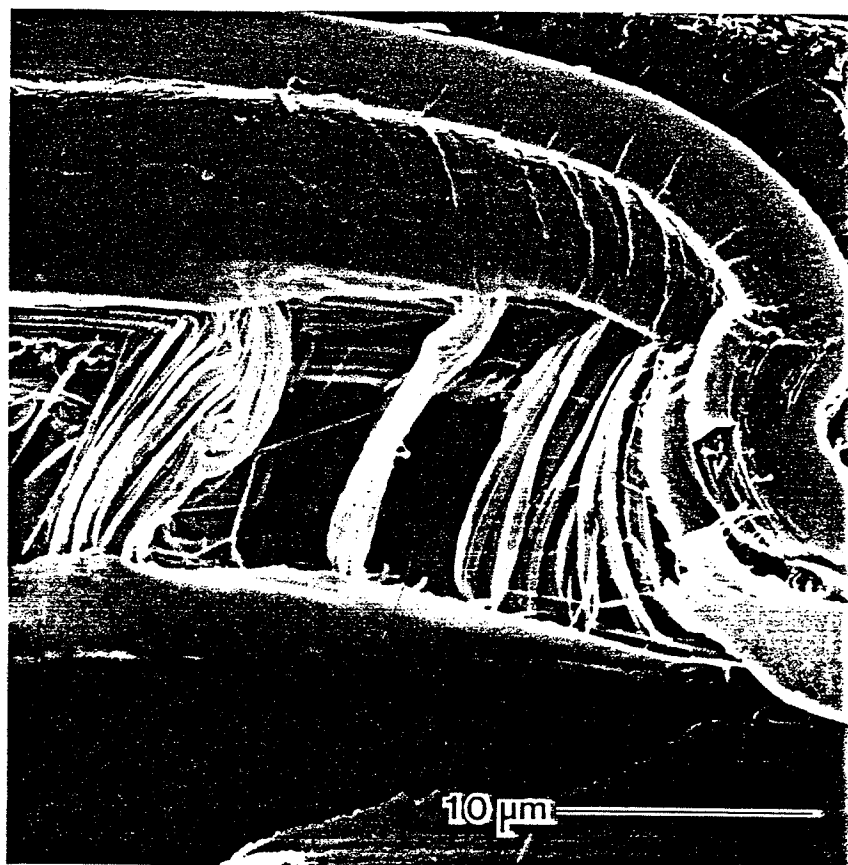
Fig. 4 Detail of Figure 3 showing the result of a gradual separation of cell wall elements.
