Challenges when retrofitting multi-storey buildings with interior thermal insulation

Challenges when retrofitting multi-storey buildings consisting of solid masonry facades and embedded wood with interior thermal insulation

Report R-386

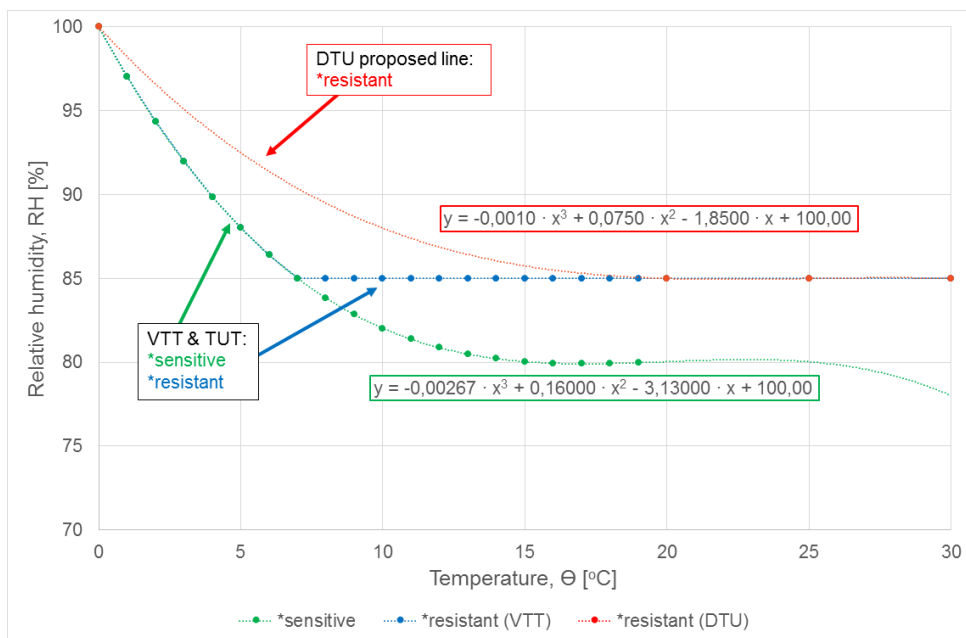
Figure 10 RHmin limits for mould growth, *sensitive and *resistant (VTT) defined in (Ojanen et al., 2010). We propose the alternative *resistant (DTU) graph, presented in the appended Paper #2.

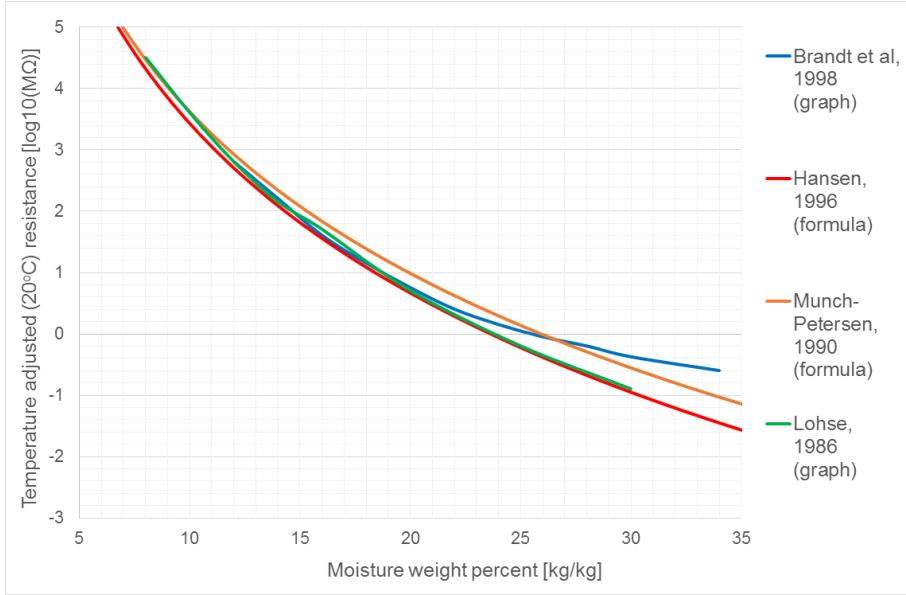
Figure 12 Different conversions from temperature adjusted $\log_{10}(MOhm)$ DC electrical wooden resistance to wooden moisture weight-% (Brandt et al., 1998; Hansen, 1996; Lohse, 1986; Munch-Petersen, 1990)

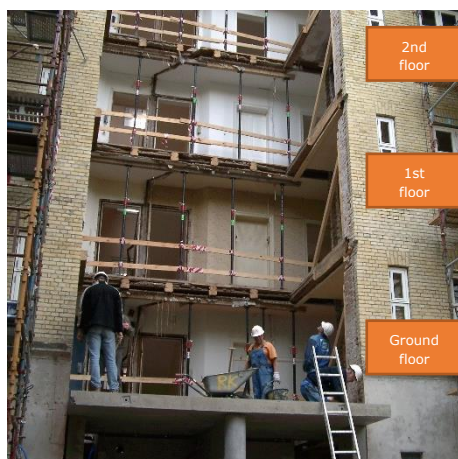
Figure 17 Opening of courtyard facade, photo showing ground until 3rd floor.

A building from 1890 has been opened from the courtyard for the implementation of modern bathrooms as shown in Figure 17 and Figure 18, revealing many of the characteristic constructional details.

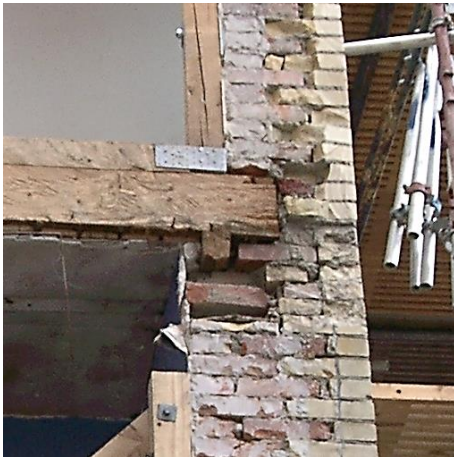
Figure 21 Facade/wooden beam interaction, 2nd floor (2 bricks) --> 3rd floor (1½ bricks).

The floor structure consists of wooden beams, with wooden floorboards on top, clay pugging placed on wooden pugging boards between the beams and wooden furring strips below as underlay for a rendered ceiling, as seen in Figure 23 and Figure 24. The wooden beam is supported by the masonry columns as seen in Figure 19, Figure 20, Figure 21, Figure 22 and Figure 29. In between the masonry columns, the wooden beam is supported by a wall plate, running along the façade, as seen in Figure 25, Figure 26, Figure 27, Figure 28 and Figure 30.

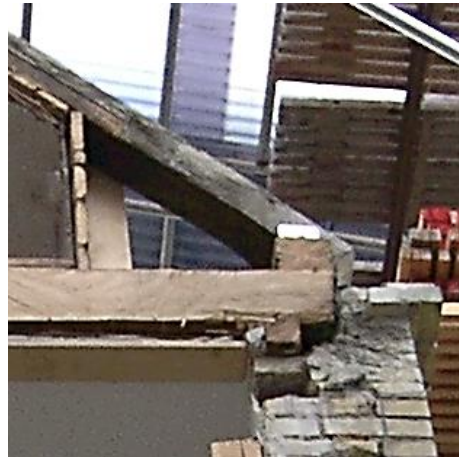
Figure 22 Facade/wooden beam interaction, 3rd floor (1½ bricks) --> 4th floor (roof).

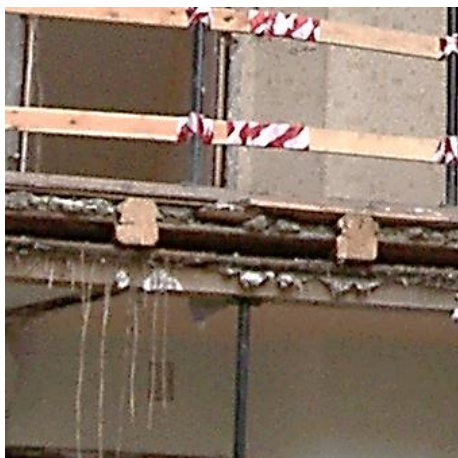
Figure 23 Wooden floor structure with wooden beam and pugging layer.

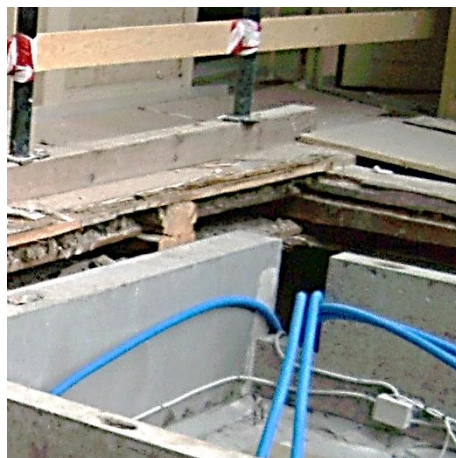
Figure 24 Wooden floor structure, note the recess in the wooden beam for pugging boards.

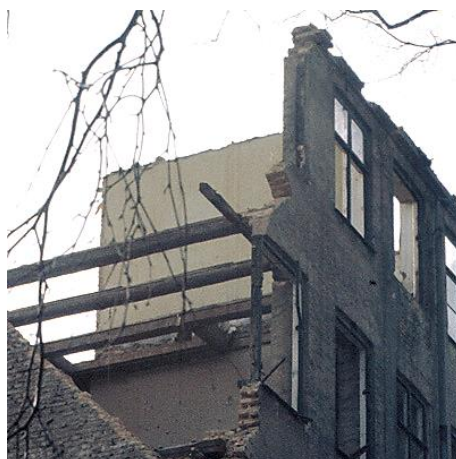
Figure 26 Wall plates and beams uncovered during demolition of building.

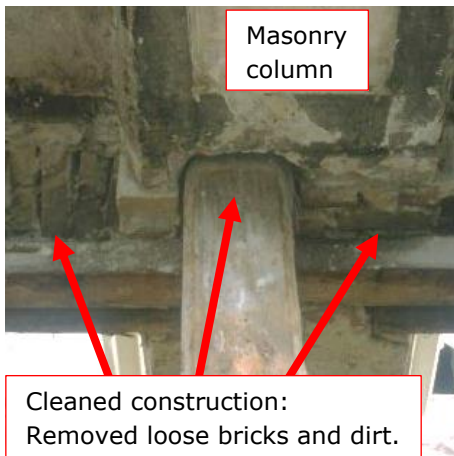
Figure 29 Cleaned up construction: Wooden beam end in masonry column, supported by a wall plate.

The constructions illustrated in Figure 29 and Figure 30 were cleaned up before taking the photograph by removing bricks, gravel and dirt by hand and brush. The original before cleaning would look similar to constructions illustrated in Figure 27 and Figure 28.

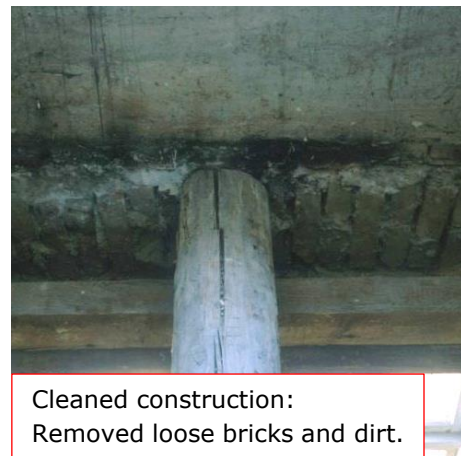
Figure 30 Cleaned up construction: Wooden beam supported by a wall plate in between masonry columns.

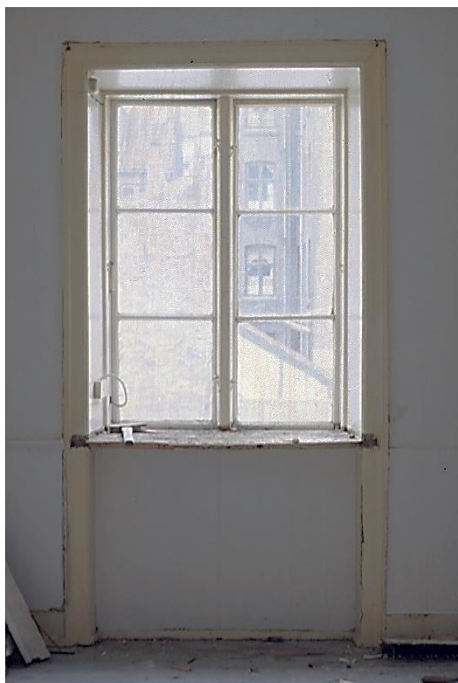
Figure 31 Interior facade wall, window section. Before dismantling finishing.

Windows were placed between the masonry columns, with spandrels completing the façade in the vertical areas between the windows and the floor decks with a constant thickness of 1 brick (240 mm), regardless of the floor number. A picture of a window section between two masonry columns can be seen in Figure 31 and Figure 32, with and without finishing towards the inside.

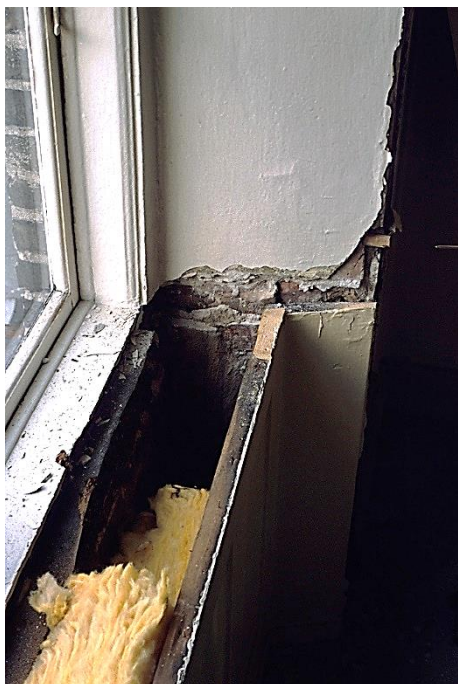
Figure 33 Timber finishing in front of spandrel. In some cases retrofitted with thermal insulation.

A picture of the finishing in front of a masonry spandrel can be seen in Figure 33, in this case with retrofitted mineral wool between the masonry and finishing. A picture showing a 1 brick thin masonry spandrel next to a 2 brick thick masonry column can be seen in Figure 34. The wall above the window had a thickness corresponding to the masonry column thickness at the given floor, with masonry resting on a lintel constructed from wood, as seen in Figure 35.

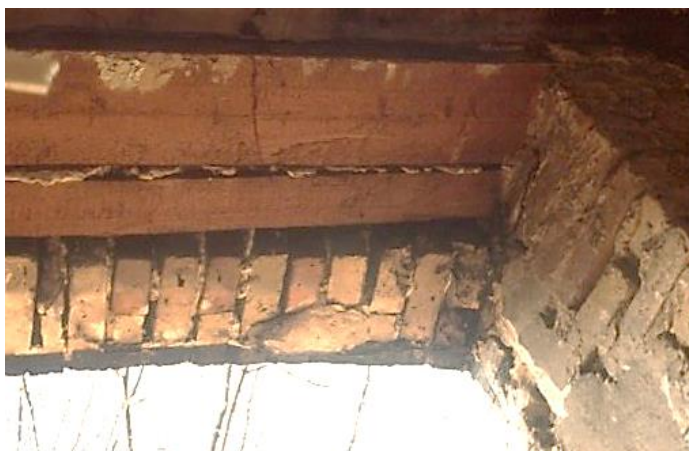
Figure 35 Lintel over window in façade. Photo courtesy of J. Engelmark

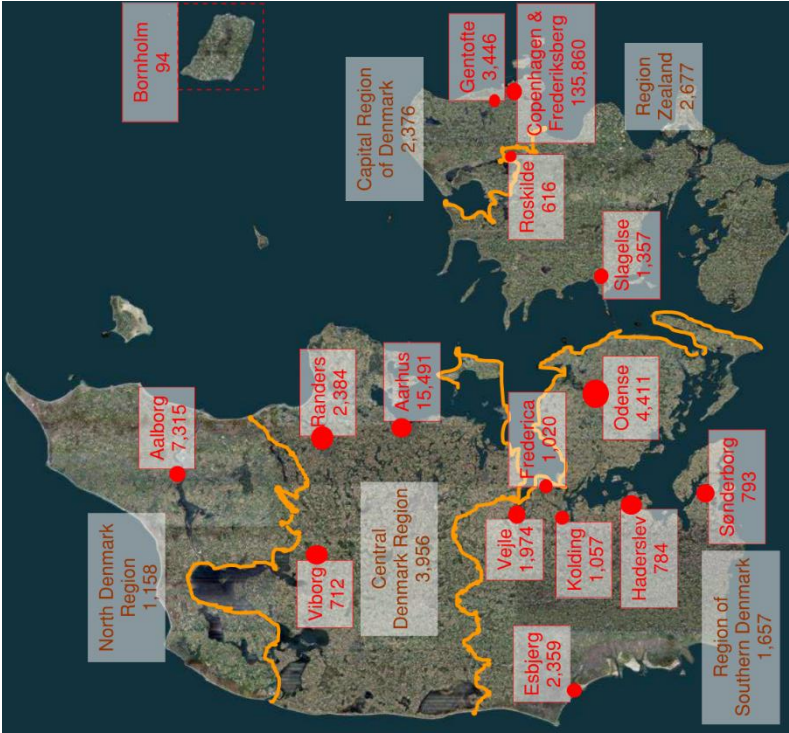
Figure 43 Regional distribution of apartments, as defined in sorting number 5 in Table 3. Same numbers presented with percentiles in Table 5. Orange lines illustrate borders of regions, orange text in box contain apartments not included in highlighted cities of region.

The regional distribution clarified via sorting number 5 of Table 3 can be seen for apartments in Figure 43 and Table 5, and number 6 on a building level in Figure 44. Most of the apartments constructed in the years 1851-1930 are situated in the larger cities of Denmark: Copenhagen/Frederiksberg; Aarhus; Aalborg; Odense; and Gentofte. The Danish capital, Copenhagen/Frederiksberg, accounted for the largest proportion of all, with 71 % of the apartment units accounted for in the figure.

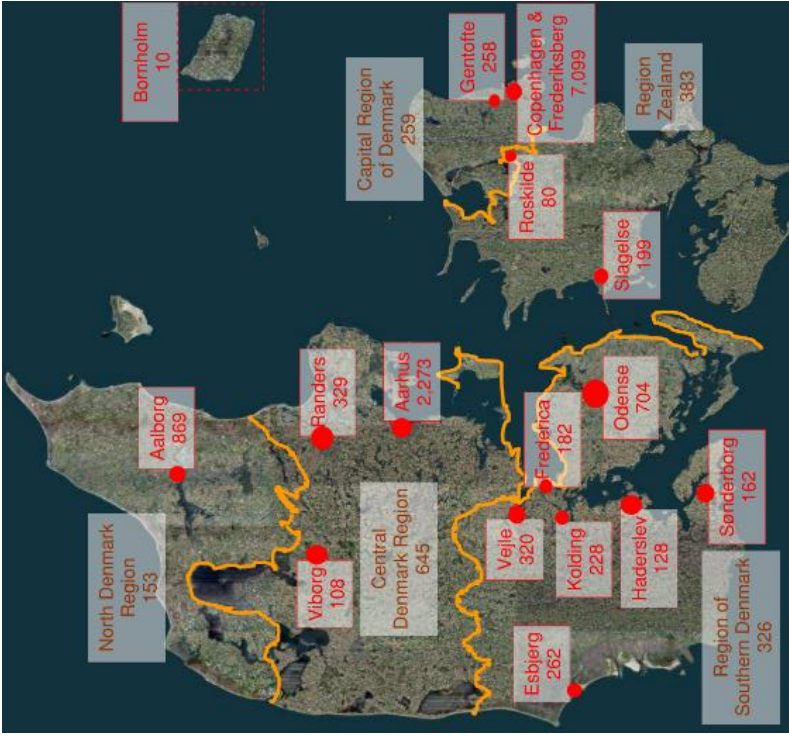
Figure 44 Regional distribution of buildings, as defined in sorting number 6 in Table 3. Orange lines illustrate borders of regions, orange text in box contain buildings not included in highlighted cities of region.

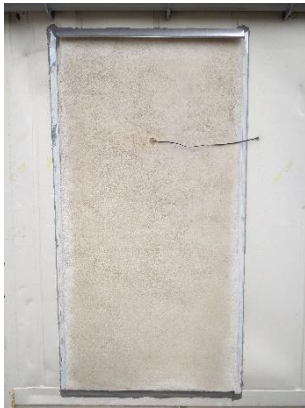
*Figure 67 Rendered exterior surface.
Container D4, Wall 1.*

- Bare brick (illustrated in Figure 68): Bare brick masonry surface, identical to the base wall.
- Hydrophobized bare brick (illustrated in Figure 69): Hydrophobic facade treatment of the bare brick masonry surface with Remmers Funcosil FC (Concentration = ~40 % w/w). The hydrophobic façade treatment was applied after drying out the walls, but before exposing them to the natural environment, retaining the salts on the surface extracted during the initial dry-out (consequently keeping the white expression of the wall as a left-over from brushing the façade with a wire brush).
- Rendering (illustrated in Figure 67): Rendered with the same lime mortar used for the mortar joints in the masonry wall.

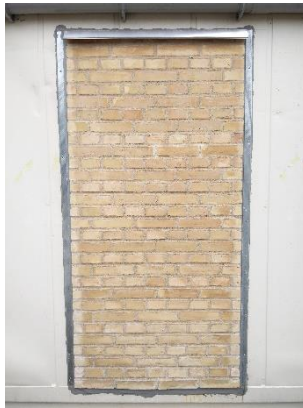
*Figure 68 Bare brick exterior surface.
Container D4, Wall 2*

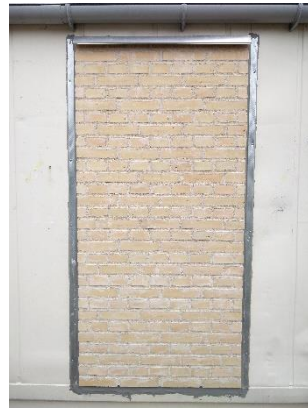
*Figure 69 Hydrophobized bare brick exterior surface.
Container D4, Wall 3.*

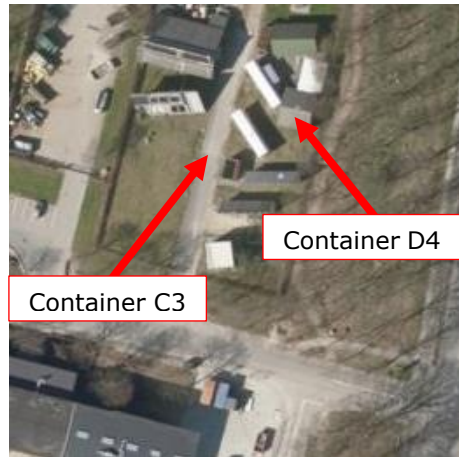
Figure 73 DTU test site in year 2017, experiment in place. Photo courtesy of Maps from COWI.

The planning of the experiment started in December 2013, Container C3 and D4 were delivered in July 2014. The state of the experimental area in the start and end of this current PhD study can be seen in Figure 72 and Figure 73 respectively, with orientation of walls illustrated in Figure 74. The construction of the masonry walls started in August 2014. First, the containers were perforated (Figure 75), then the masonry walls were constructed by professional masons (Figure 76). The measurements points were pre-installed into bricks and wooden elements beforehand, which were then installed by the masons (Figure 77). The wooden beam was installed, and rendering was applied to all interior surfaces (Figure 78). Construction of the walls with installation of vapour barriers and thermal insulation to reduce the walls influencing each other were finished in November 2014. In the period from November 2014 until April 2015, forced dry-out of the walls were done. The walls were protected against rain with a canopy on the outside, and high temperatures and low relative humidity were applied on both sides of the walls to force a dry-out. The dry-out was followed by regular Troxler measurements.

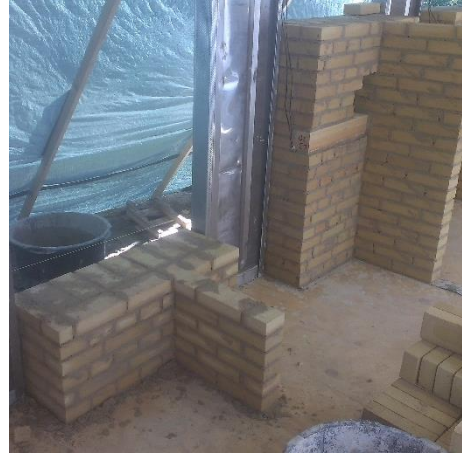
Figure 76 Construction of solid masonry walls with embedded wooden elements.

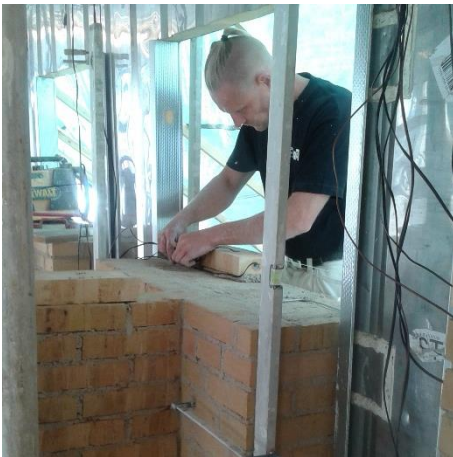
Figure 77 Mason installing brick with pre-installed sensors at measurement point 1.

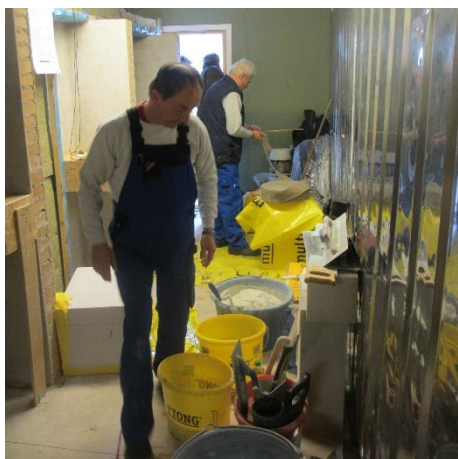
Figure 79 Thermal insulation is installed by the producers following system guidelines.

The various insulation systems were installed when the masonry walls had dried out sufficiently. The insulations systems were installed by the producers, following normal guidelines including reinforcement, as seen in Figure 80. The different systems and surface treatments were installed at the following times:

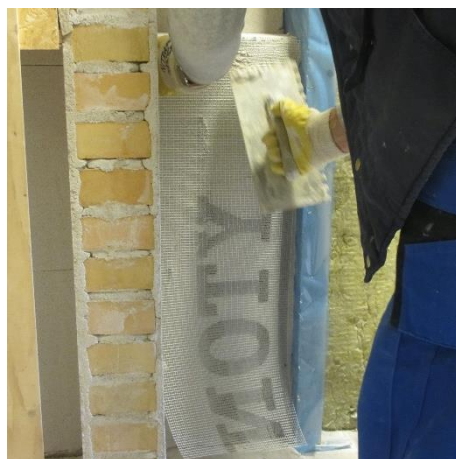
Figure 80 Thermal insulation is installed by the producers following system guidelines.

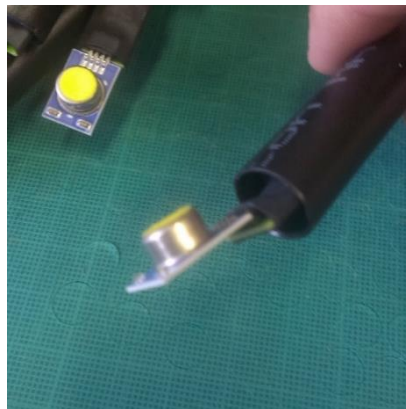
Figure 87 Sensor connected to cable, before covering and applying heat to adhesive lined shrink tubing.

The digital RH/T "HYT 221" sensor module from IST are delivered as print boards, as illustrated in Figure 86. The connection from the sensor module to the patch panel was done via a "sensor cable for EK-H3/H4" from Sensirion. The two products was connected and covered with adhesive lined shrink tubing for protection, as illustrated in Figure 87, Figure 88 and Figure 89. The finished protected sensor can be seen in Figure 89, where only the yellow net covering the sensor area is uncovered.

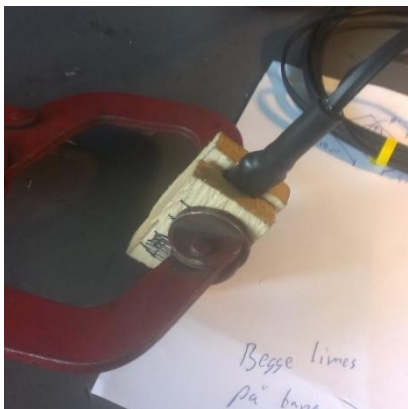
Figure 88 Applying light pressure to mold after heating up adhesive lined shrink tubing, to ensure a protective layer of glue and shrink tubing on the print board.

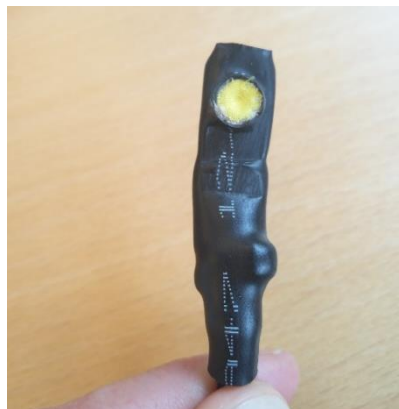
Figure 89 Finished protected sensor and cable connection. Yellow net was covered with cardboard during heating, to avoid glue covering the sensor area.

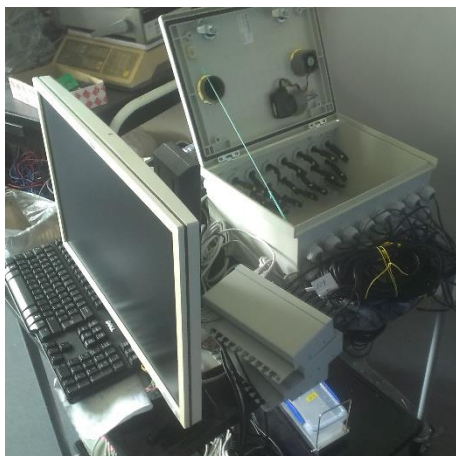
Figure 90 Set-up for calibration: Isolated box with various known salt solutions.

After protecting the sensor and cable as described in Section 5.2.4.2.1, the measured relative humidity for each individual sensor was calibrated over known saturated salt solutions. This calibration was done in a moisture-tight box with an internal fan, as illustrated in Figure 90, in a room with stationary temperature conditions. The measured relative humidity for each sensor was calibrated in the following ad- and desorption steps, where each step was validated using a Rotronic Hygrometer A2, calibrated prior to the process over certified Rotronic ampoules:

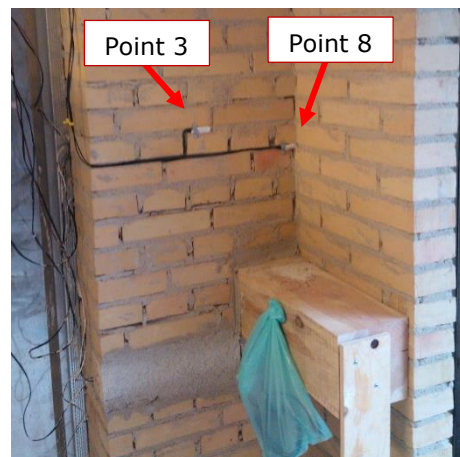
Figure 93 Sensor Point 3 and 8: Measurement point closest to the original interior surface of the masonry wall. Photo courtesy of Søren Peter Bjarløv.

- Point 1 (illustrated in Figure 92): Digital RH/T sensor, wooden dowel and gypsum dowel, mounted in brick. The digital RH/T sensor and wooden dowel was installed from opposite ends of the brick, 1/3 into the brick length. The gypsum dowel was installed from the top of the brick. All sensors were installed in the middle of the brick width, resulting in 54 mm from exterior façade surface.
- Point 2 (illustrated in Figure 92): Digital RH/T sensor, mounted 57 mm from brick end pointing towards the exterior surface, in middle of masonry wall, 177 mm from exterior surface.
- Point 3 & 8 (illustrated in Figure 93 and Figure 94): Digital RH/T sensors, mounted on interior masonry surface, covered by rendering. Point 3 had a horizontal measurement point 240 mm from the partition, point 8 was placed against the partition.

Figure 108 96-hour average of measured temperature and relative humidity. Mould index is calculated based on non-smoothed values. Results from Wall 1 (illustrated in Figure 105) and Wall 3 (illustrated in Figure 106), measurement Point 3 (illustrated in Figure 93) and Point 4 (Figure 95), locations of both further illustrated in Figure 66.

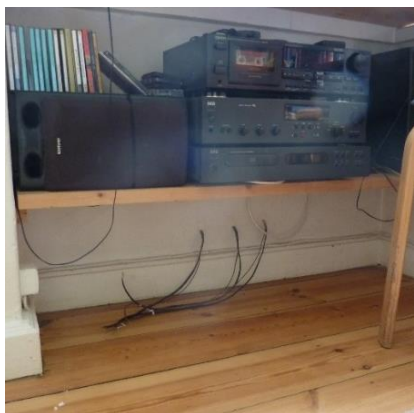
Figure 122 Interior surface of un-insulated spandrel in room 12.

Two similar spandrels in each their room were monitored in this study, over a period of 2 years and 8 months. One spandrel was kept as a reference, illustrated in Figure 122, and the other was retrofitted with thermal insulation on the interior masonry surface, illustrated in Figure 123. 2-dimensional drawings of the insulated wall can be seen in Figure 124.

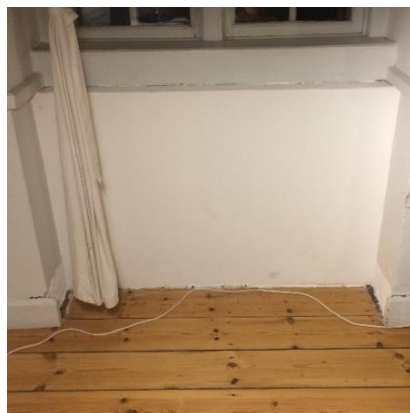
Figure 123 Interior surface of insulated spandrel in room 09.

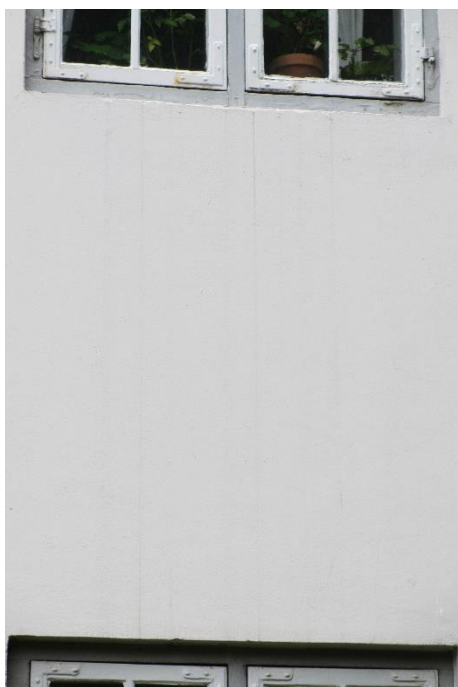
Figure 144 Exterior surface of the insulated spandrel, June 2014.

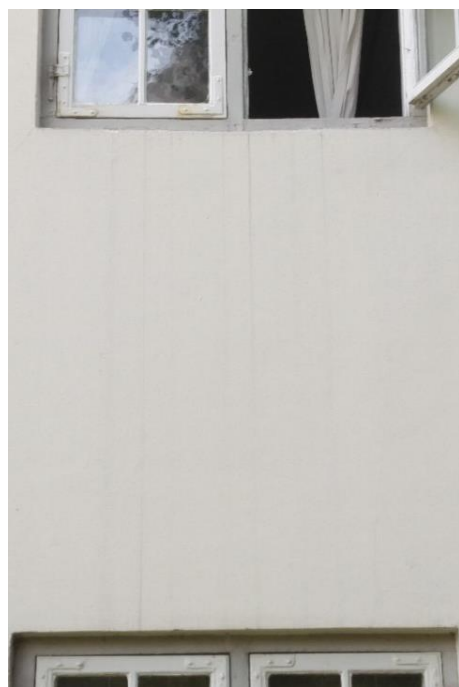
Figure 145 Exterior surface of the insulated spandrel, July 2017.

Considering the risk of frost damage of the exterior façade, it is clear that the changed hygrothermal conditions with colder and wetter masonry walls results in a worse state than the initial. The case in Borchs dormitory was investigated visually for frost risk during the experiment, showing no damage at the exterior surface from June 2014 (illustrated in Figure 144), to 1 year after the end of the monitoring period in July 2017 (illustrated in Figure 145).

The case in Borchs dormitory was investigated visually for frost risk during the experiment, not observing any frost damage of the exterior surface from June 2014 (illustrated in Figure 144), to the final visual inspection one year after ending the monitoring in the masonry, in July 2017 (illustrated in Figure 145).

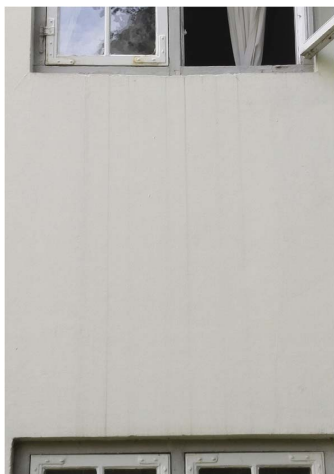
Fig. 10. Last visual inspection of exterior surface of insulated spandrel on 2017-07-24.
