Skeppsholmbron

An assessment of the condition of timber from foundation no.3

Preben Hoffmeyer & Ulla Gjøl Jacobsen
Building Materials Laboratory
Technical University of Denmark
1994.05.07

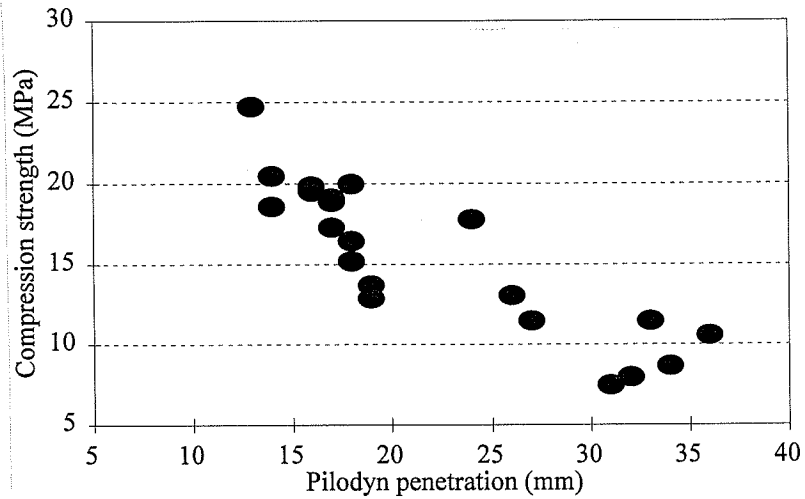
Figure 1 *Compression strength along the grain against Pilodyn penetration*

The Pilodyn penetration results are given in Table 4 above and the relationship to compression strength along the grain is illustrated in Figure 1 (page 7). The results suggest that the Pilodyn may be used as a non-destructive tester of marine timber strength. It can not be used underwater in its standard configuration. However, a modified version is known to have been used under such conditions.

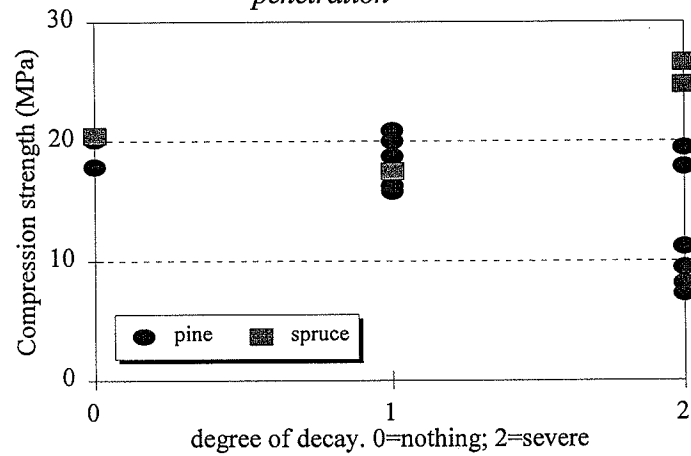
Figure 2 *Compression strength against degree of decay. 0="no decay"; 1="incipient decay"; 2="decay"*

The main results of Hussvamlaboratoriet's decay assessment are listed in Appendix B. In order to illustrate the relationship between strength and decay as assessed by microscopy, a rating was introduced. "No decay" was given the value 0, "incipient decay" was given the value 1 and "decay" was given the value 2. The relationship is depicted in Figure 2 (page 7), which illustrates that the identification of "decay" does not automatically mean that the particular prism has lost its load capacity. Although the weak prisms are indeed all identified as having decay, there are even prisms (spruce) with decay which retain their original strength.

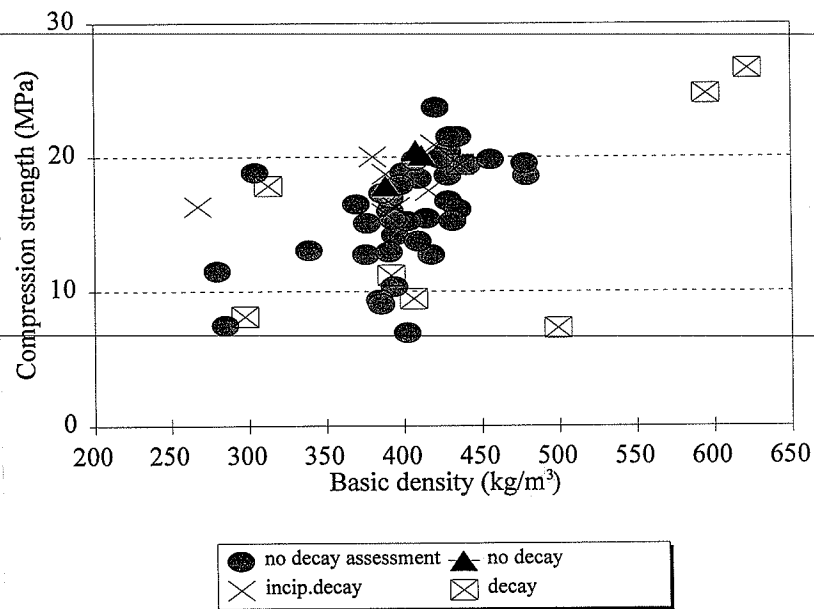
Figure 3 *Compression strength against basic density.*

Figure 3 (page 7) illustrates that the relationship between compression strength and basic density is very weak for wood prisms which shows various degrees of decay.

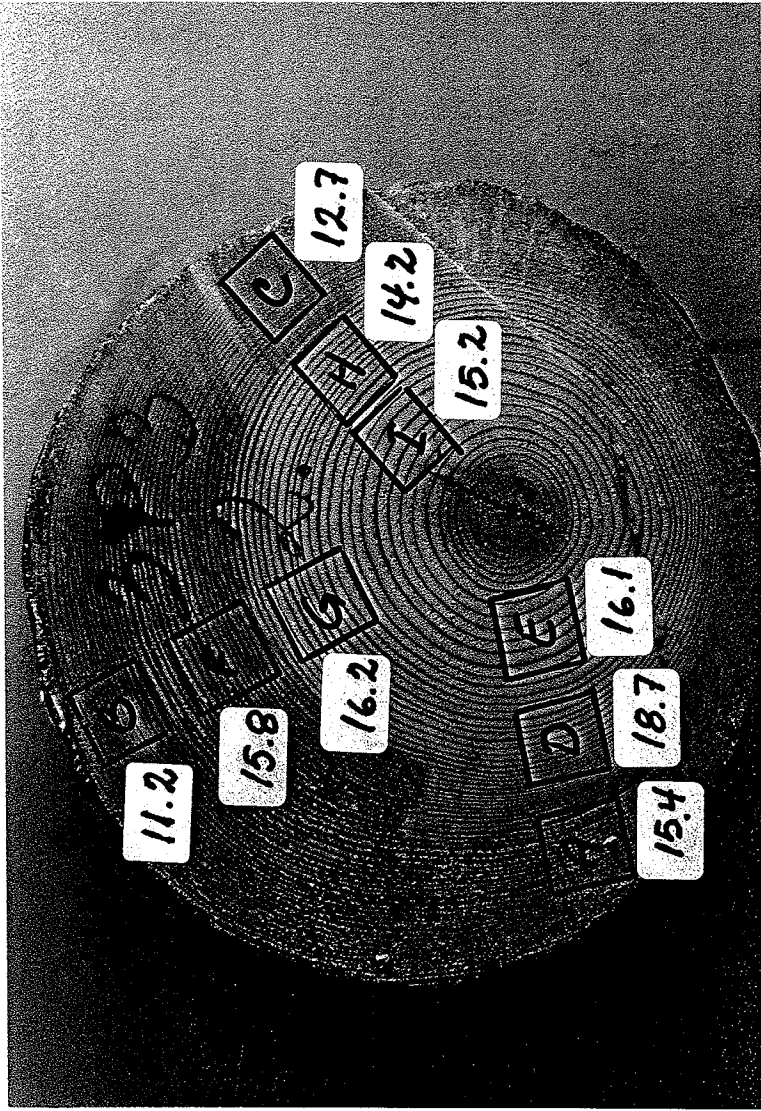
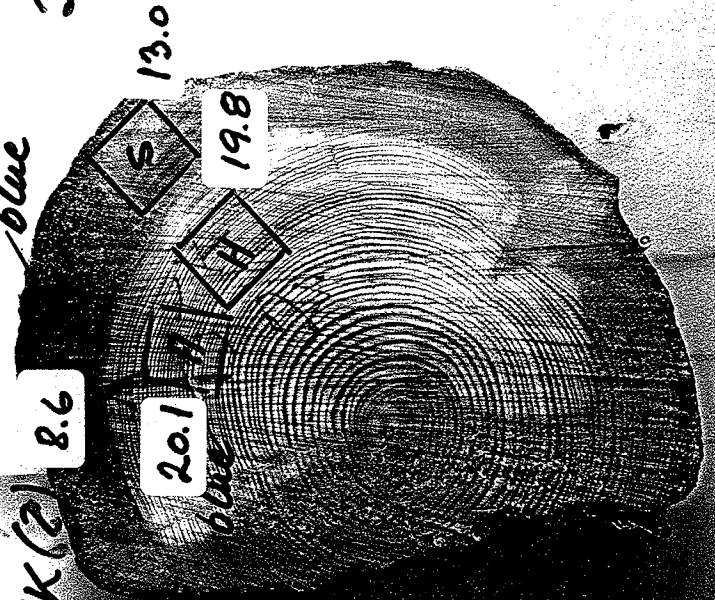
3TK(2) 8.6 blue 3TK2

TK.1	15 % of cross section is sapwood. Sapwood decayed. Heartwood sound. Cross section dimensions 205x240 mm. An ø35 mm increment core has been removed from this sample at an earlier occasion.
TK.2	10 % of cross section is sapwood. Sapwood decayed. Heartwood sound. Cross section dimensions 205x240 mm.

Location of prisms in the cross section
Superimposed values of compression strength along the grain
