Results from measurements on two insulated solar walls

Søren Østergaard Jensen

THERMAL INSULATION LABORATORY
TECHNICAL UNIVERSITY OF DENMARK
REPORT NO. 247 MARCH 1993

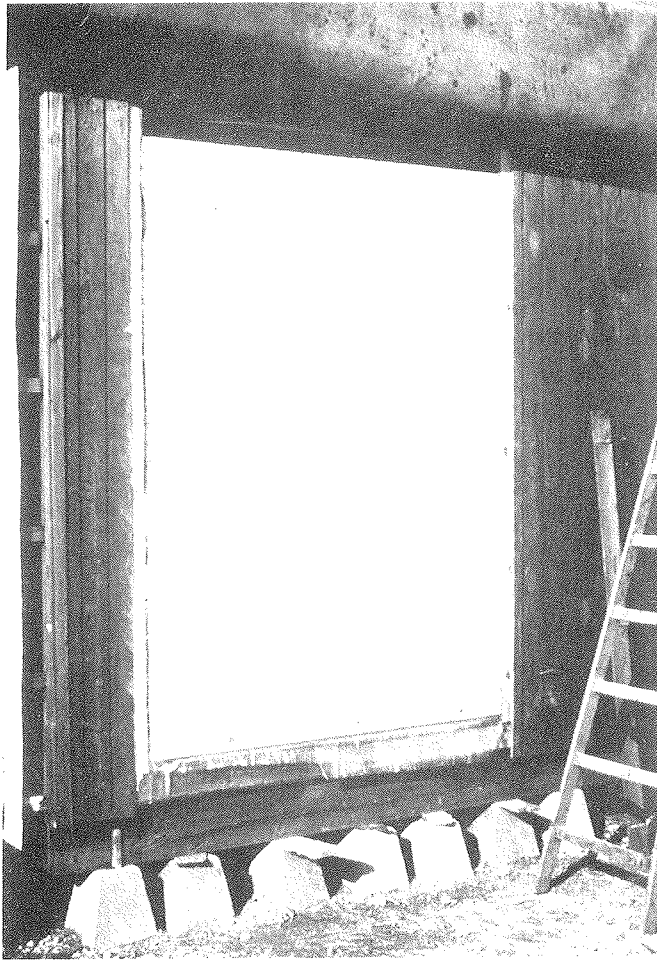
Figure 2.4 The mass component before installation of the rest of the solar wall.

A vertical section of the mass component is shown in fig. 2.3. The thickness of the walls were 0.228 m. Figure 2.4 shows one of the mass components before the rest of the solar wall was installed. Figure 2.5 shows a close-up of the mass component. A more detailed description of the mass components can be found in ref. [1].

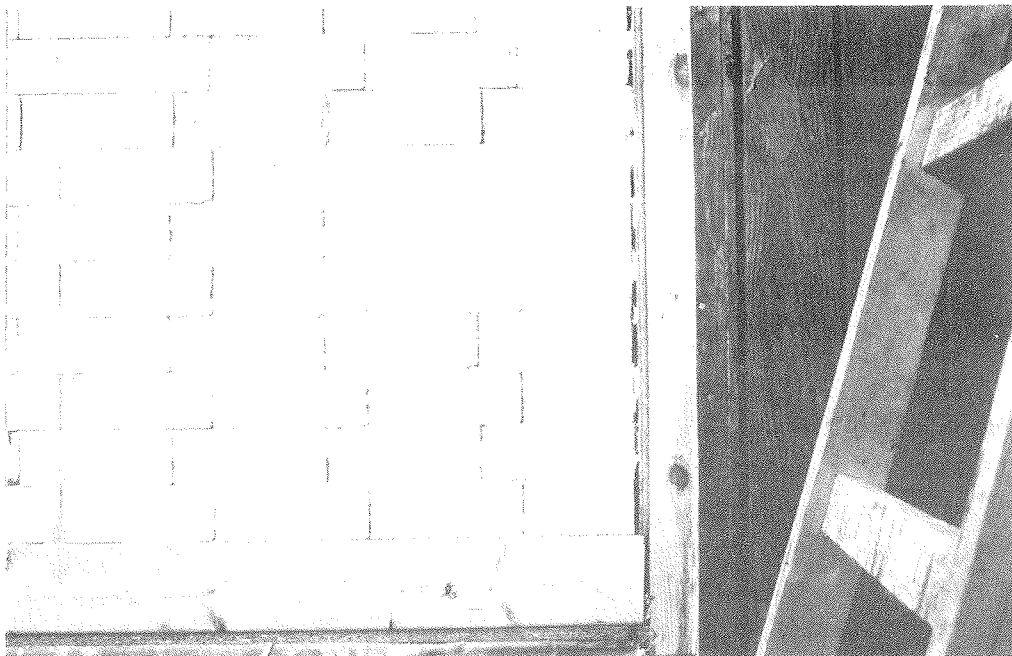
Figure 2.5 Close-up of the mass component.

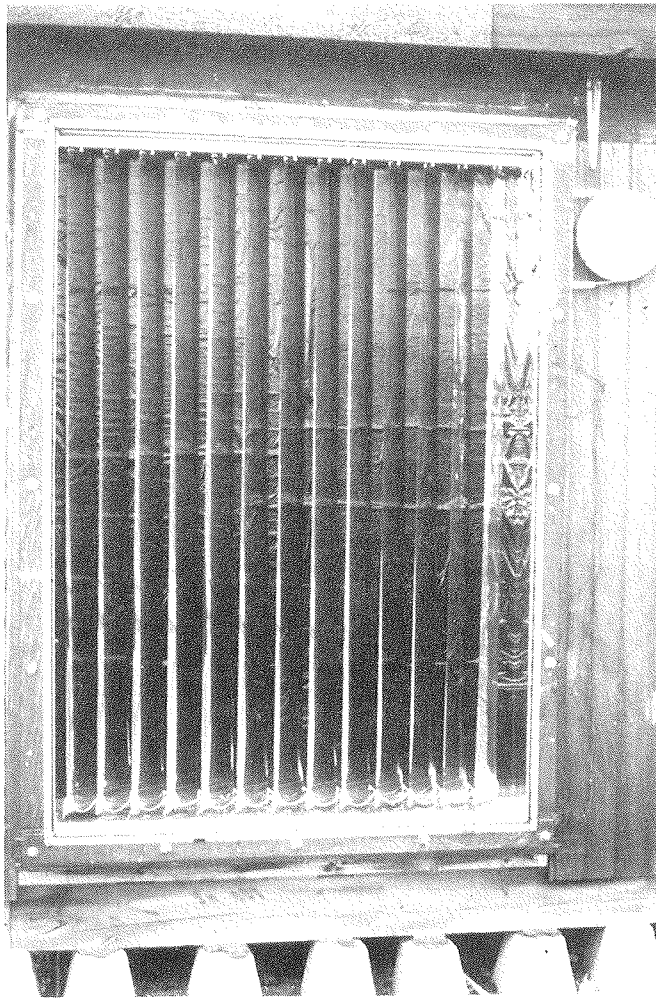
Figure 2.7 Photograph of the solar wall with the blind.

The solar wall was, as already mentioned, equipped with a vertical turnable blind between the mass component and the cover. The cover consisted of 5 mm ordinary glass. The transparent area of the solar wall was approximately 2.91 m². Selective foil (Maxorb) was fastened to the outer surface of the mass component in order to reduce the radiative heat loss from the solar wall further. Figure 2.7 shows the solar wall. The wheel at the top right corner of the solar wall was for operating the blind. The wheel was connected to a damper motor and a timer. The blind was operated in such a way, that the slats of the blind were always parallel to the solar beams during the day and closed during the night. Figure 2.8 shows the traverse rod for turning the blind.

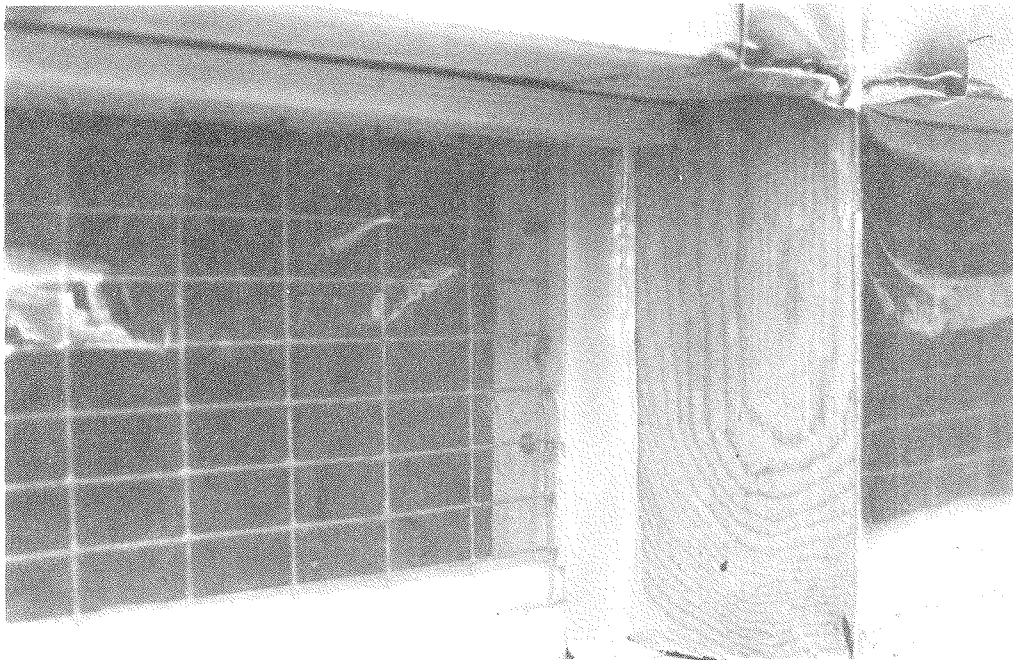
Figure 2.20 Top damper of the internally ventilated Trombe wall. Note the grid and the Teflon foil.

The solar wall had an insulating panel between the mass component and the absorber. A transparent cover of 5 mm ordinary glass was further mounted in front of the absorber. At the top and bottom of the insulating panel were two openings allowing the air to circulate between the two air spaces on each side of the insulating panel. A plastic foil (Teflon) and a grid were mounted in the openings at the top and bottom of the insulating panel. The plastic foil and grid acted as a damper with a built-in non-return valve. The air was thus only allowed to circulate in one direction - up along the back of the absorber and down along the mass component. In this way heat loss by counter-flow during the night was prevented. Figure 2.13 shows a photograph of the solar wall, while figs. 2.14-17 show the design of the wall in detail. Figure 2.18 shows the insulated panel before installation and figs. 2.19-20 show the bottom and top damper, respectively.

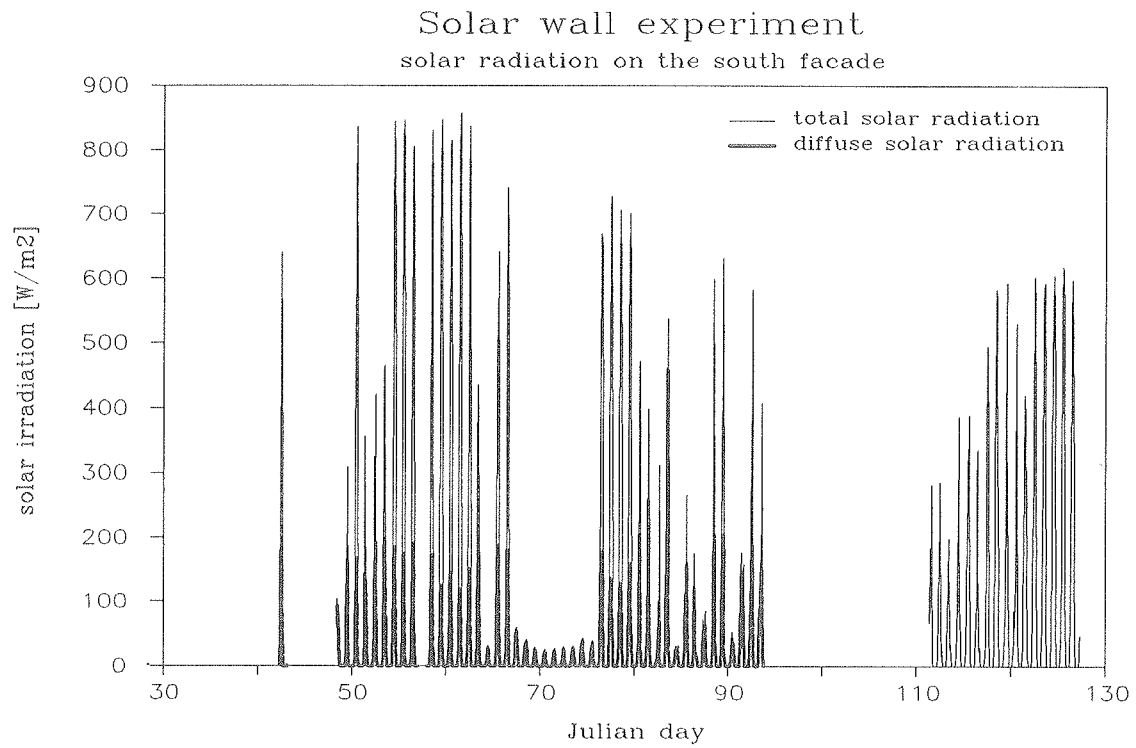
Figure 3.2 The total and diffuse solar irradiation on the south facade of the experimental building - January 30-May 7.

There were, as seen in fig. 3.2, problems with the pyranometers, used for measuring the solar radiation, during the first period. During the last period only the total radiation is shown as the measured diffuse radiation often turned out to be larger than the total radiation after the correction for the shading ring - see fig. 2.22. The reason for this is most probably that the shading ring was not properly adjusted so that the pyranometer was often measuring the total radiation.

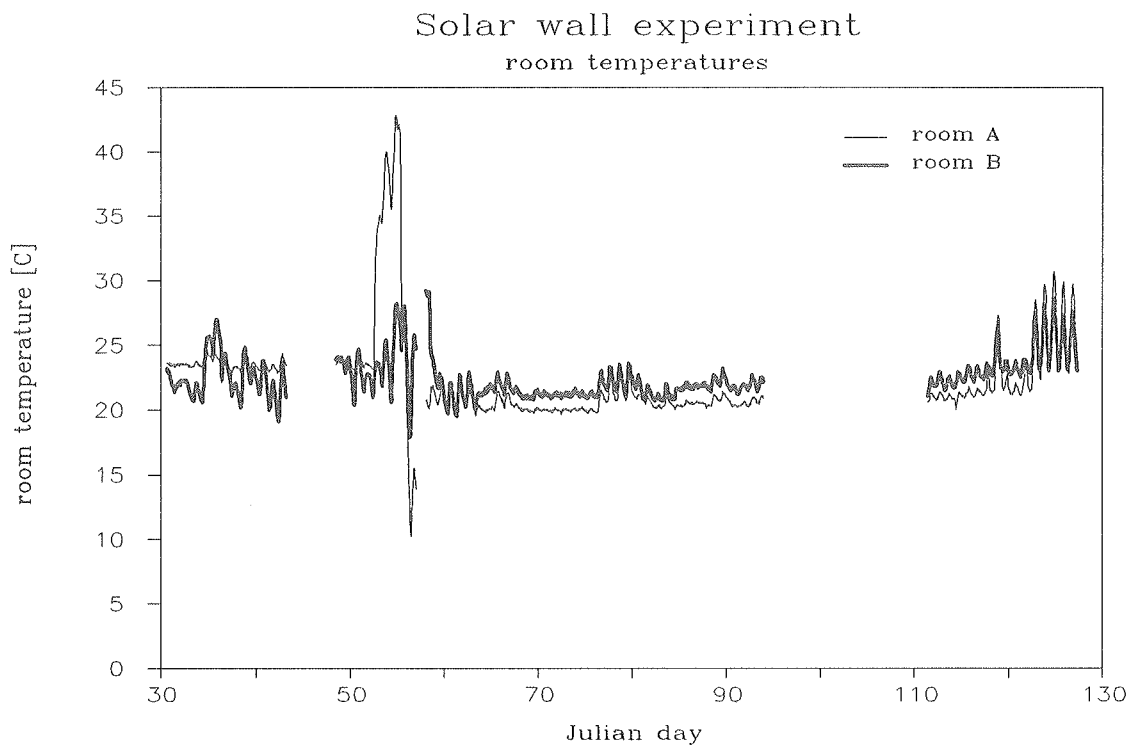
Figure 3.4 The air temperature of the test rooms during the experiment - January 30-May 7.

Figure 3.4 shows the room temperature of room A and B (see fig. 2.1) with the solar walls. Figure 3.4 shows that the room temperatures were very unstable until day 60. Figure 3.5 shows the heat fluxes through the inner surfaces of the mass components - positive values are heat gains to the room, while negative values are heat losses. This figure illustrates also the unstable conditions until day 60. Especially the large heat loss from room B to the mass

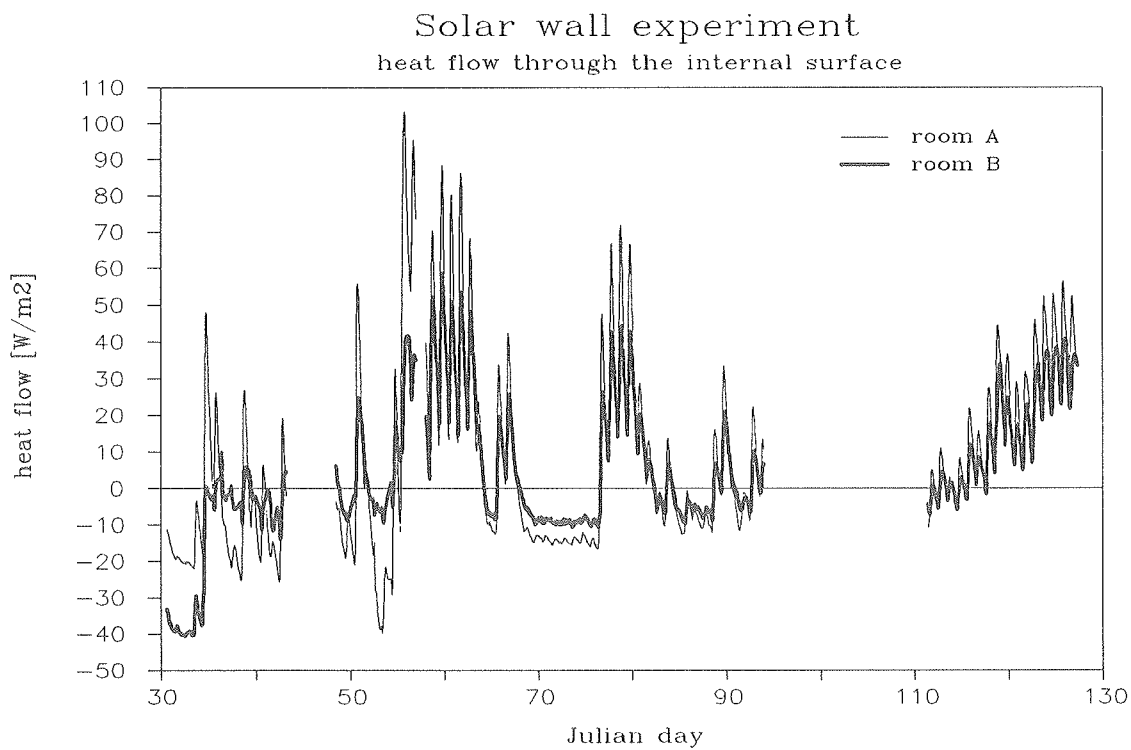
Figure 3.5 The heat fluxes through the internal surfaces of the mass components during the experiment - January 30-May 7.

component at the beginning of the experiment. The explanation for this may be, that the rooms were unheated until the beginning of the experiment. So the large "heat loss" was really heat input used to raise the temperature of the mass components to stable conditions.

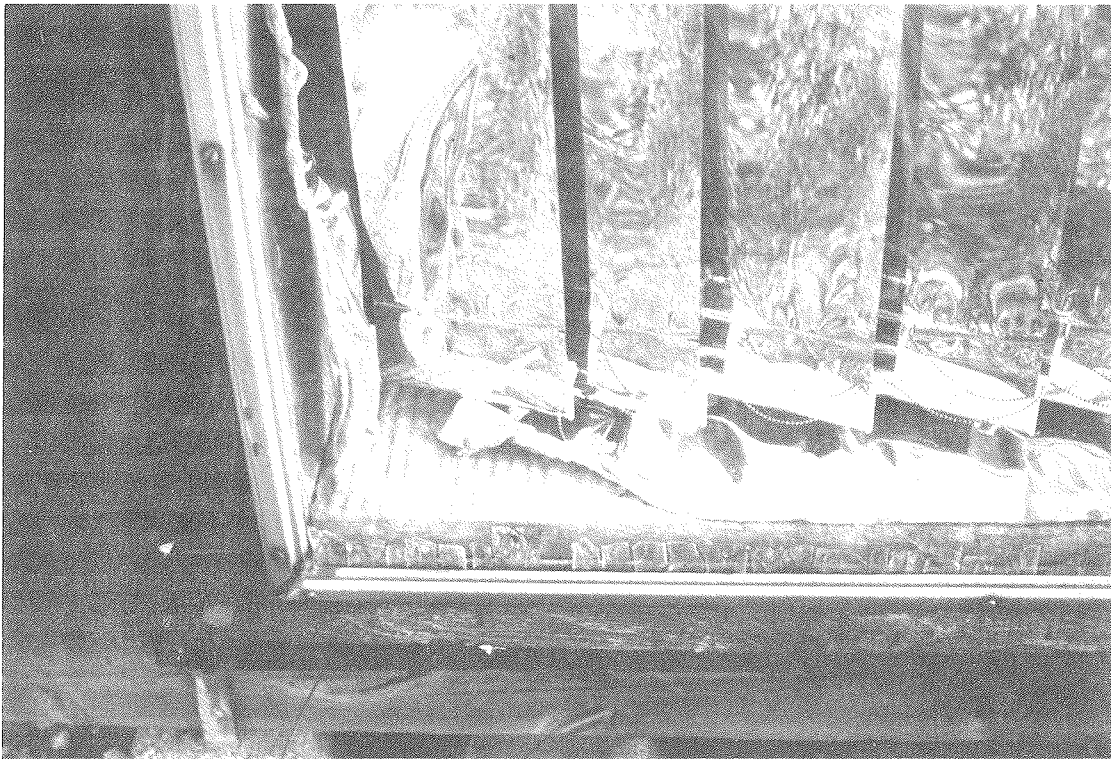
Figure 4.1 The bright adhesive plastic foil on the additional insulation on the thermo laths of wall 1 had after three and a half years lost its adhesive ability and had crumpled up.

During the demolition, the constructions were inspected in order to detect any degeneration of the walls. The only detected damage was, that the bright plastic foil on the additional insulation on the thermo laths of wall 1 (see figs. 2.11-12) had lost its adhesive ability and had crumpled up.
