# Influence of alkali-silica reaction on the physical, mechanical, and structural behaviour of reinforced concrete

PhD Thesis

Department of Civil Engineering  
2017

DTU Civil Engineering Report R-363

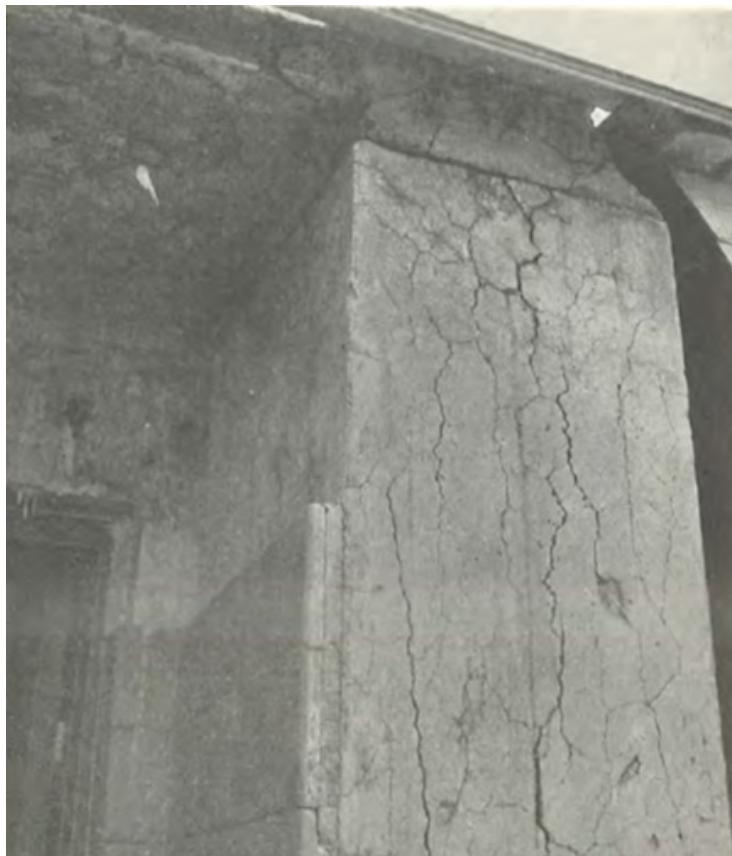
**Figure 1.3:** Crackling in a Danish concrete bridge. Photo adapted from (Nerenst 1952), taken in the early 1950s.

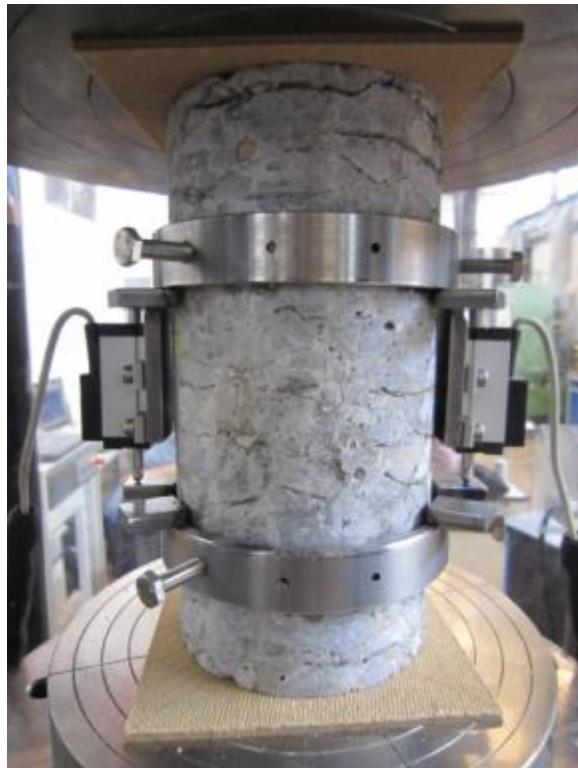
Fig. 3: Test setup for the uniaxial compressive test. The deformations during loading were measured by two LVDTs placed between rigid rings closely fixed to the concrete core.

During the compressive tests the vertical deformations of the cores were logged by an LVDT on each side of the core as shown in Fig. 3. The core tests were conducted with 3-mm-thick high density wood fibre boards between the cores and steel loading platens.

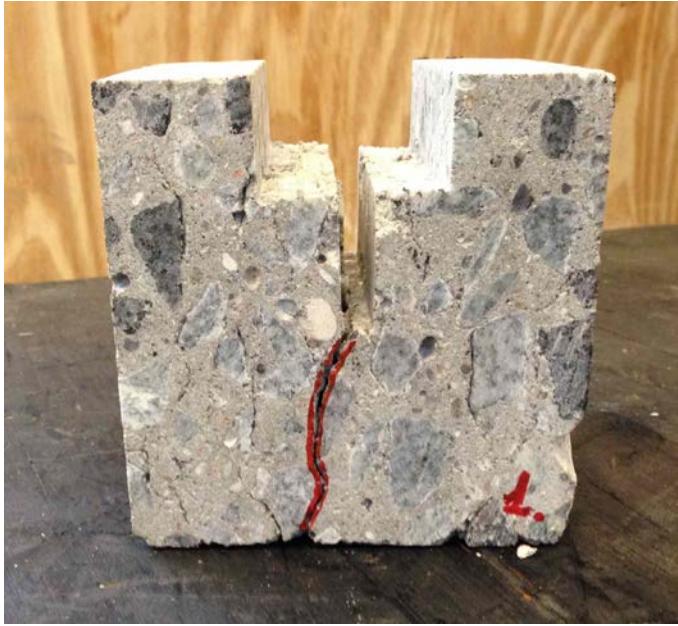
Fig. 12. WST cube with orientation I after testing. The ASR cracks were opened due to the splitting load.

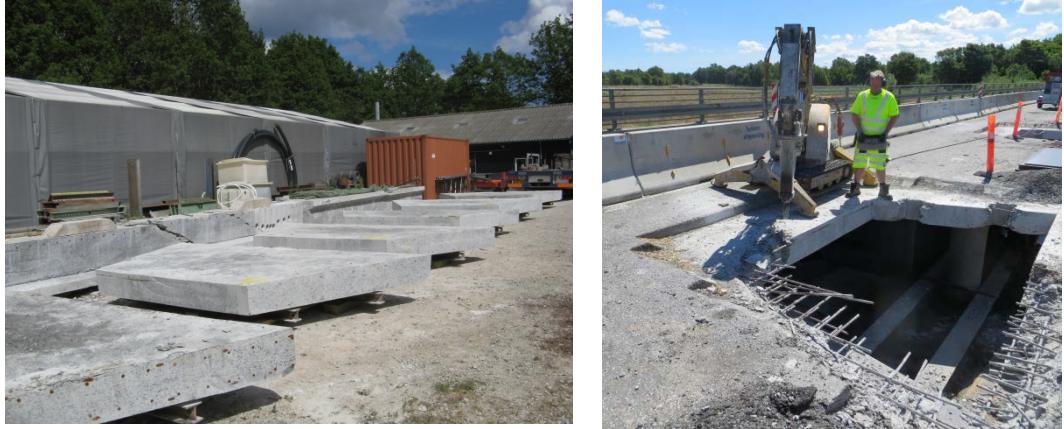
Figure 1: (a) Sawn slab segment at laboratory facility of the Technical University of Denmark. (b) The bridge slab after sawing of a segment.

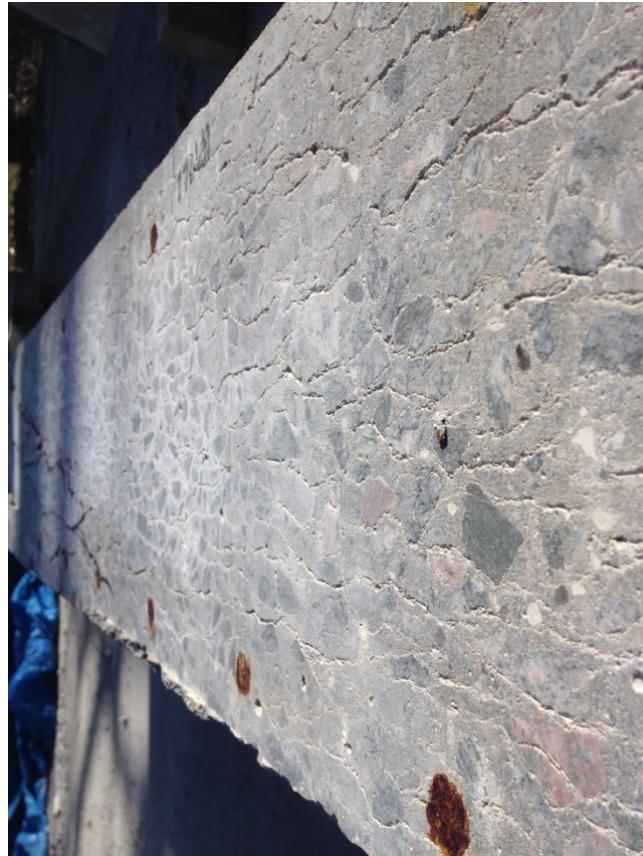
Figure 3: Typical ASR crack pattern on the section of segment 5.

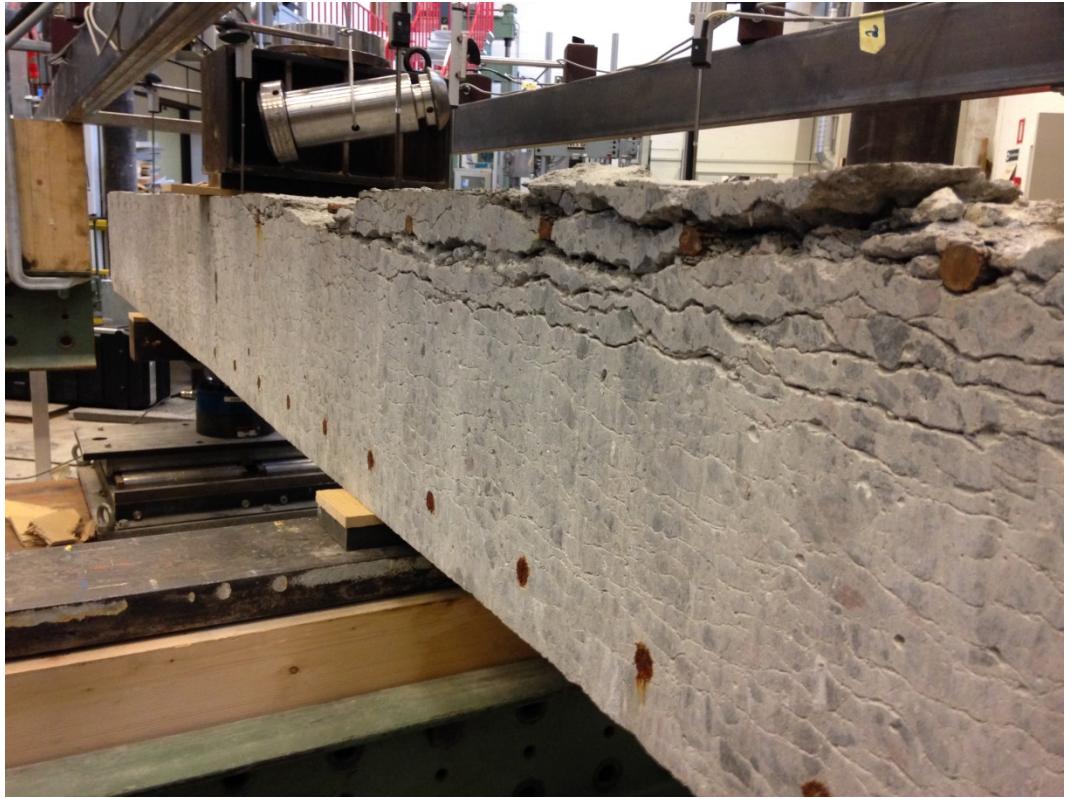
Figure 4: Local increase in crack widths in compression zone of a beam from segment 6 due to combined effect of ASR and corrosion.

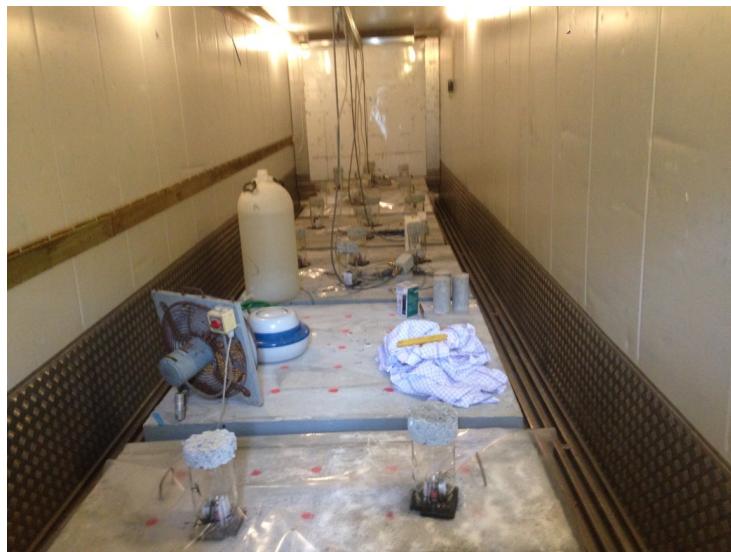
**Figure 5.2:** Reinforced slabs inside the insulated 40-ft container.

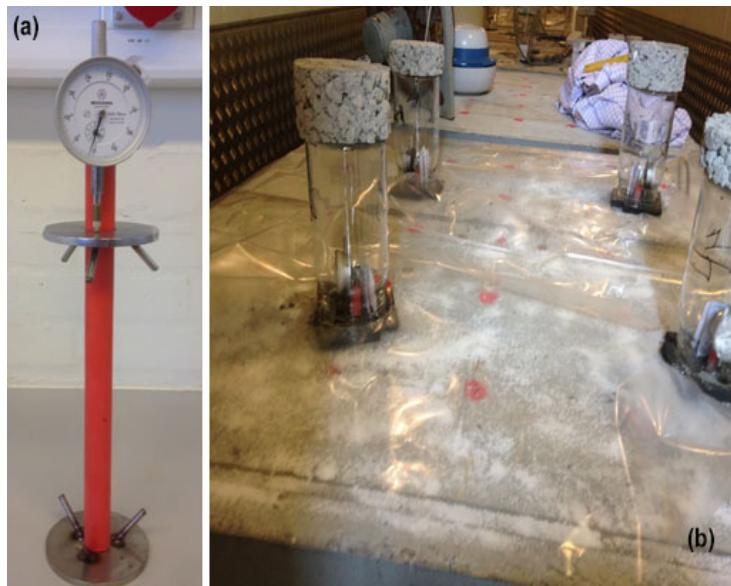
**Figure 5.4:** Internal vertical expansion measurement setup. (a) Vertical expansion measurement device. (b) Vertical expansion measurement device casted inside the slabs.

Figure 5.4a shows a photo of the internal vertical expansion measurement device which consists of a vertical plane reinforcement bar welded to a steel foot. The plane bar was protected by a rubber tube that, prevents anchorage of plane bar to the concrete. A Mitutoyo dial gage with 0.01-mm precision was installed on top of the vertical device. Round steel plates were casted on the top surface of the slabs in order to ensure a plane surface for the vertical expansion measurements. Figure 5.4b shows the vertical measuring device after casting on the slabs. Glass jars installed onto the slab surface were used to protect the dial gages from the high-humidity environment inside the container. Small silica-gel packs were placed inside the glass jars. Between the jars and the concrete, closed-pore flexible heat insulation material was glued to the surface, to prevent moisture entering to the dial gages. The vertical expansion was measured on six slabs; see Table 5.2. In slab 5, only one vertical expansion measurement device was installed in the slab. The first readings of the dial gages was conducted at 20°C and all the following readings were conducted at 40°C inside the container.
